Building Site Location Report for Lot 436

Our ref: 20533

Building Site Location Report

Lot 436 of Stage 2H

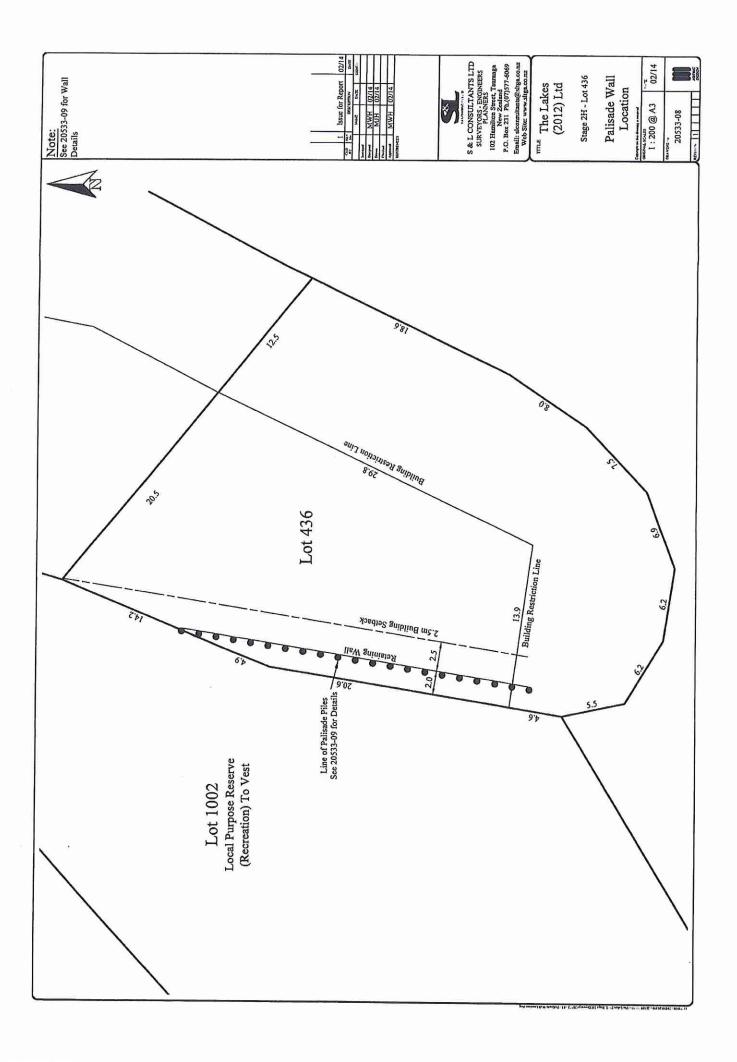
We recommend that a subsurface palisade wall system be installed as shown on attached drawings 20533-08 and 20533-09. Underground piles would provide a "retaining wall" to confine the filling placed in 2007 behind the wall, if instability of the adjacent batters did take place. The wall system would be located 2.0 m from the western boundary as shown on 20533-08.

To avoid the possibility of a future house surcharging the palisade wall it is recommended that future buildings should be located at least 2.5 m away from the line of this wall. Such a setback is applicable because, in the event that the wall does become loaded due to loss of ground in front of the wall, horizontal deflections on the wall poles may be of the order of 150 mm with associated ground movement immediately behind the wall. In addition, the piled wall has not be designed to support significant surcharges from future buildings.

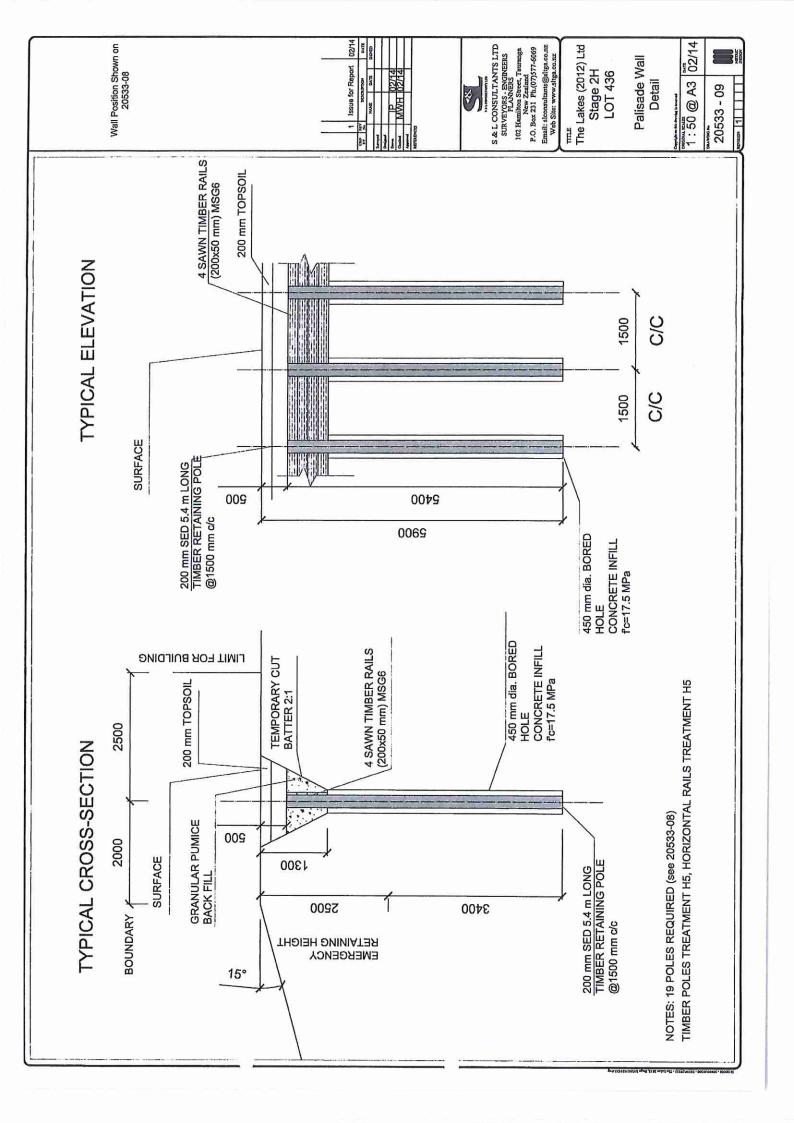
The wall system has been designed as a line of temporary support only and it would be incumbent on the owner of lot 436 to have any lost ground in front of the wall reinstated immediately, under professional geotechnical advice.

An analysis of the slope profile with the palisade wall in place shows that any failure surface would then pass under the embedded poles, and that stability factors of safety would be in excess of 2.0.
