**THE LAKES DEVELOPMENT
STAGE 2F
PYES PA, TAURANGA**

Report on Earthworks and
Recommendations for Development

Our ref: 20180
July 2012

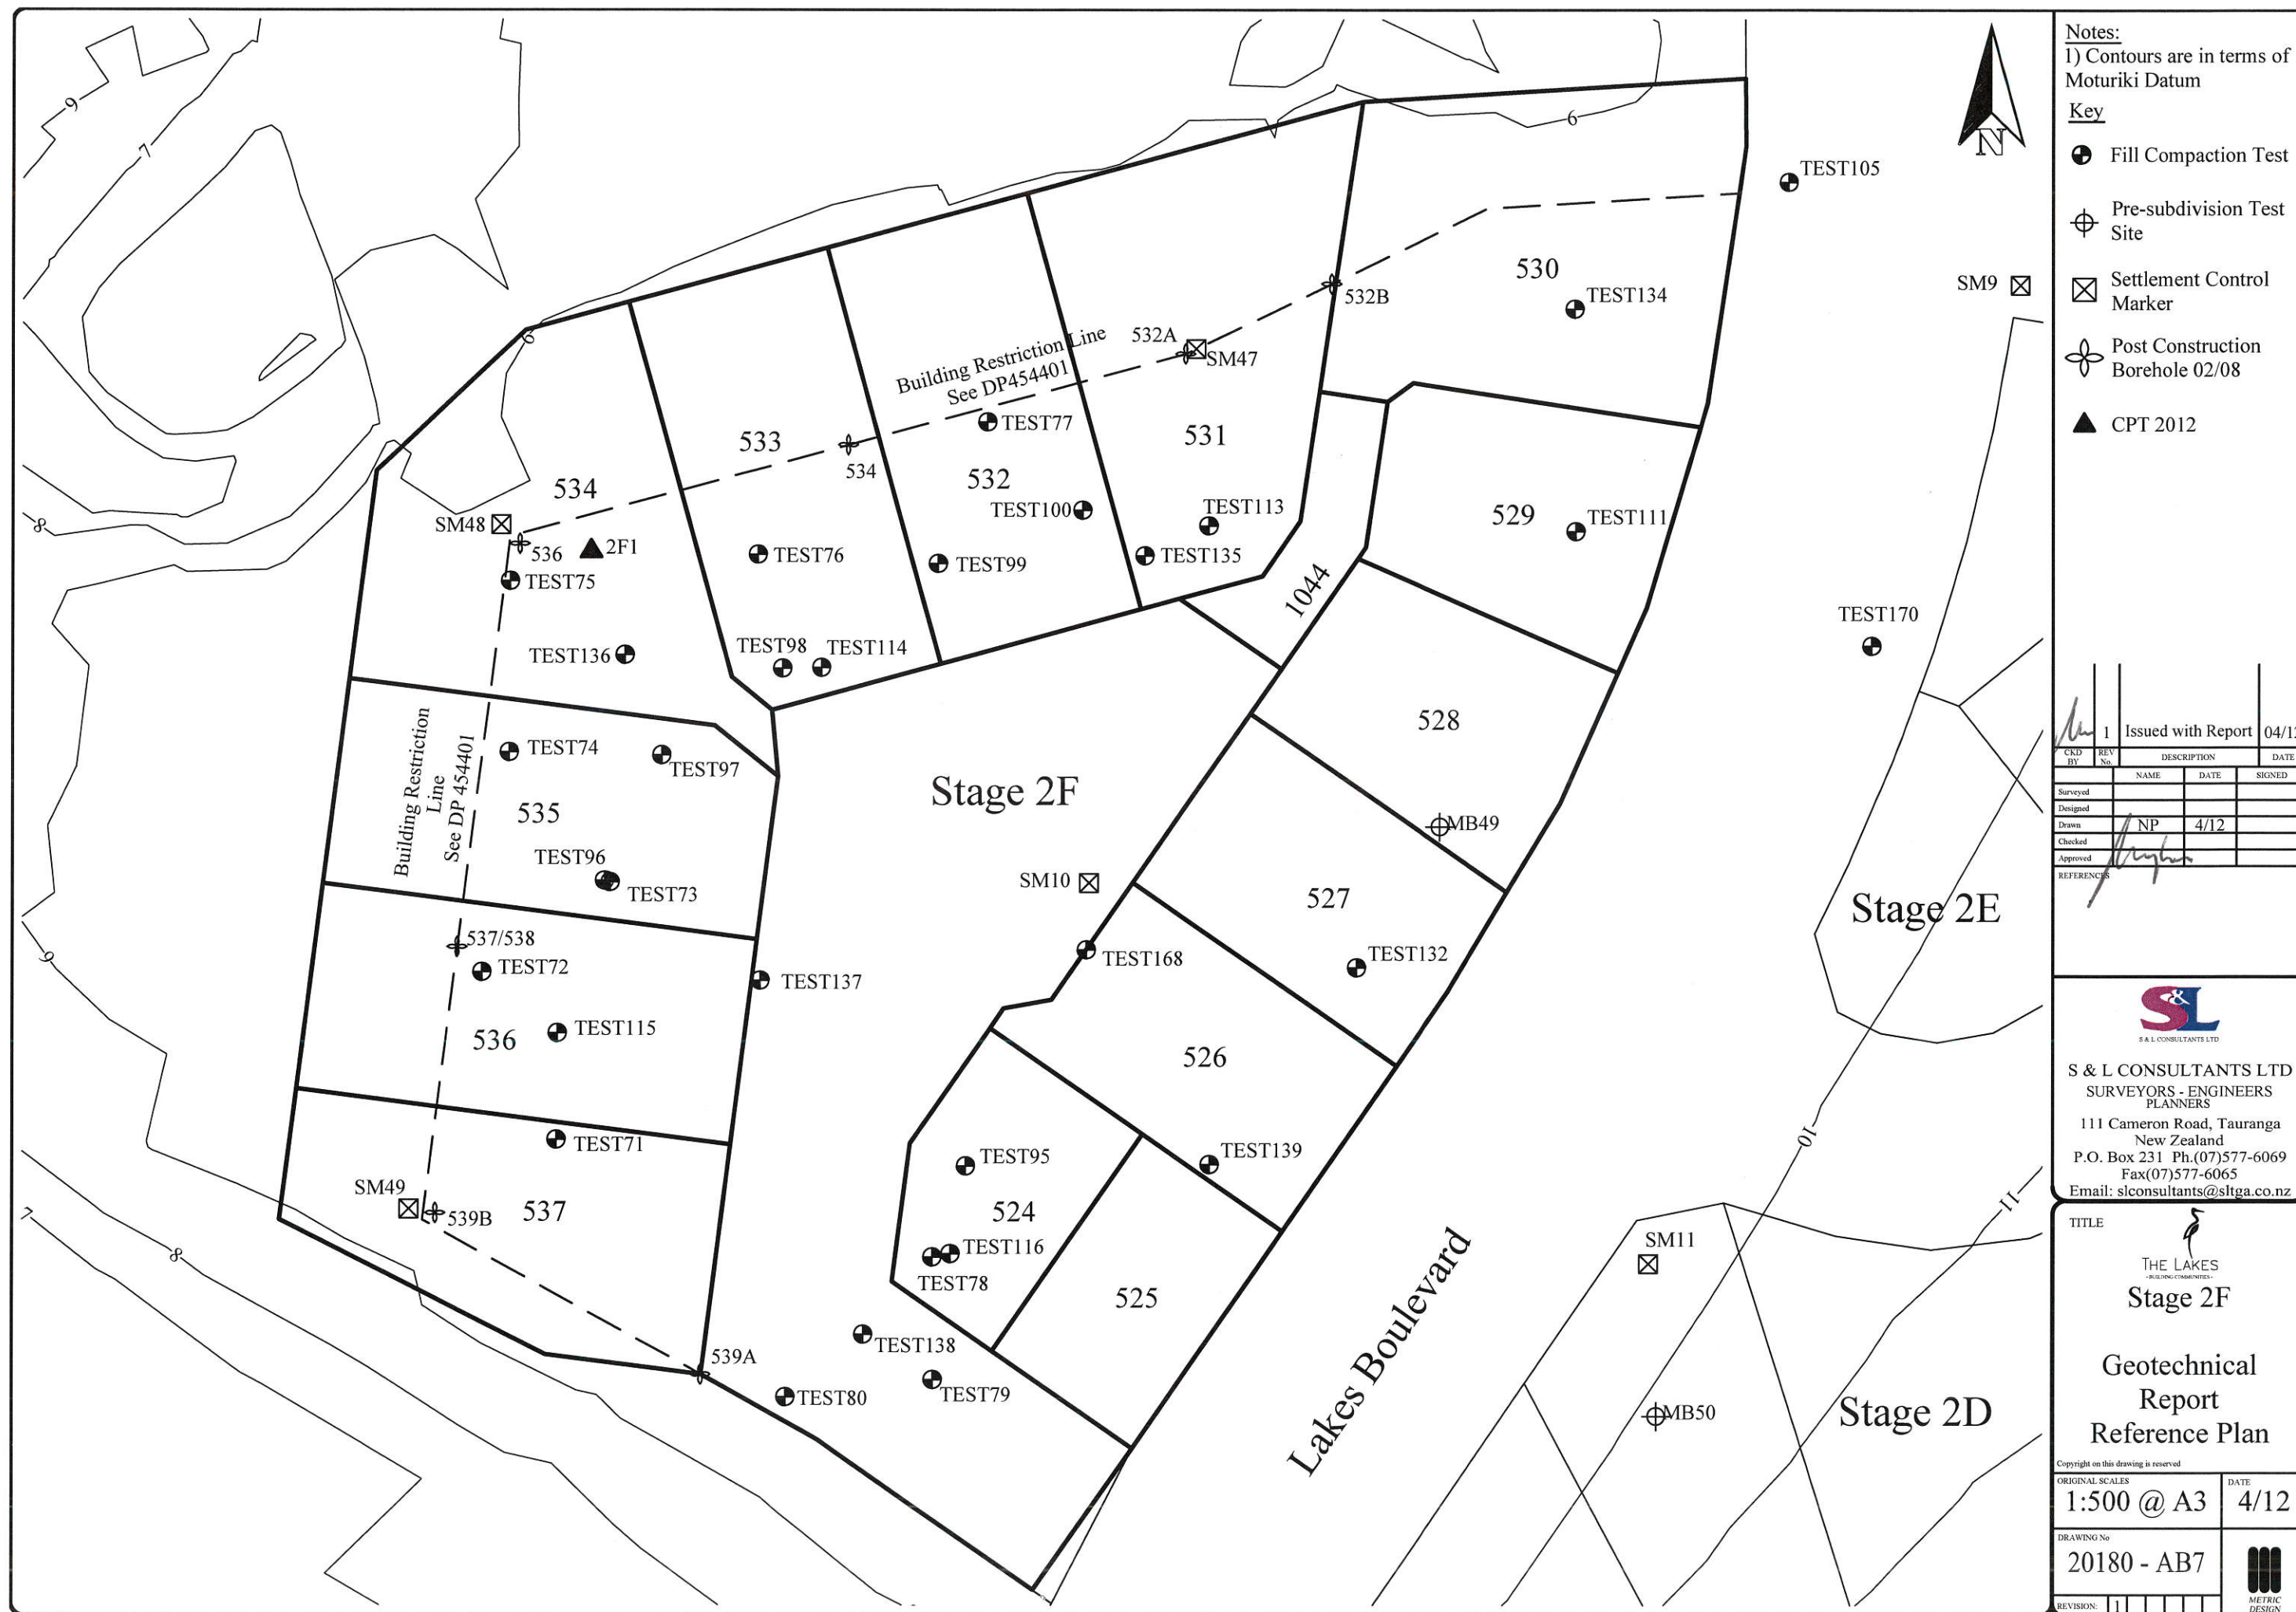
TITLE	THE LAKES -BUILDING COMMITTEES- Stage 2F Geotechnical Report Reference Plan
Copyright on this drawing is reserved	
ORIGINAL SCALES	DATE
1:500 @ A3	4/12
DRAWING No	
20180 - AB7	
REVISION: 1	
	METRIC DESIGN

Appended drawing 20180-AB7 indicates the finished ground contours as the result of the completed earthworks and the positions of compaction tests undertaken during the earthworks, and post construction settlement control markers. Drawing 20180-AB8 shows the depths of the filling that was placed. As shown on 20180-AB7 the finished ground levels are essentially flat.

27 compaction tests were undertaken within the areas of filling within the Stage 2F area at locations shown on 20180-AB7. The results of these tests are summarised in Appendix 3.

After placement of the filling in Stage 2F, six settlement markers were installed at locations shown on 20180-AB7. The levels on these markers were surveyed over a period of up to 180 days. The survey results are within Appendix 3. The degrees of settlement fluctuated over the monitoring period with variations up or down possibly due to the expected accuracy of the survey. Recorded monthly settlements in the period of 12 September to 10 October 2007 when the surveys ceased were in the range of 1 to 3mm. The trends during the monitoring period indicate that any future settlement will be within tolerable limits for future buildings constructed on surface foundations.

For the study on the liquefaction potential in the Stage 2F area, 1 cone penetrometer (CPT) test was undertaken by Perry Drilling at locations shown on 20180-AB7. At the probe position the static groundwater level depth was recorded at 2.80m

During the report reference is made to drawings 20180-AB7 and 20180-AB8 which are also in Appendix 1 of this report.

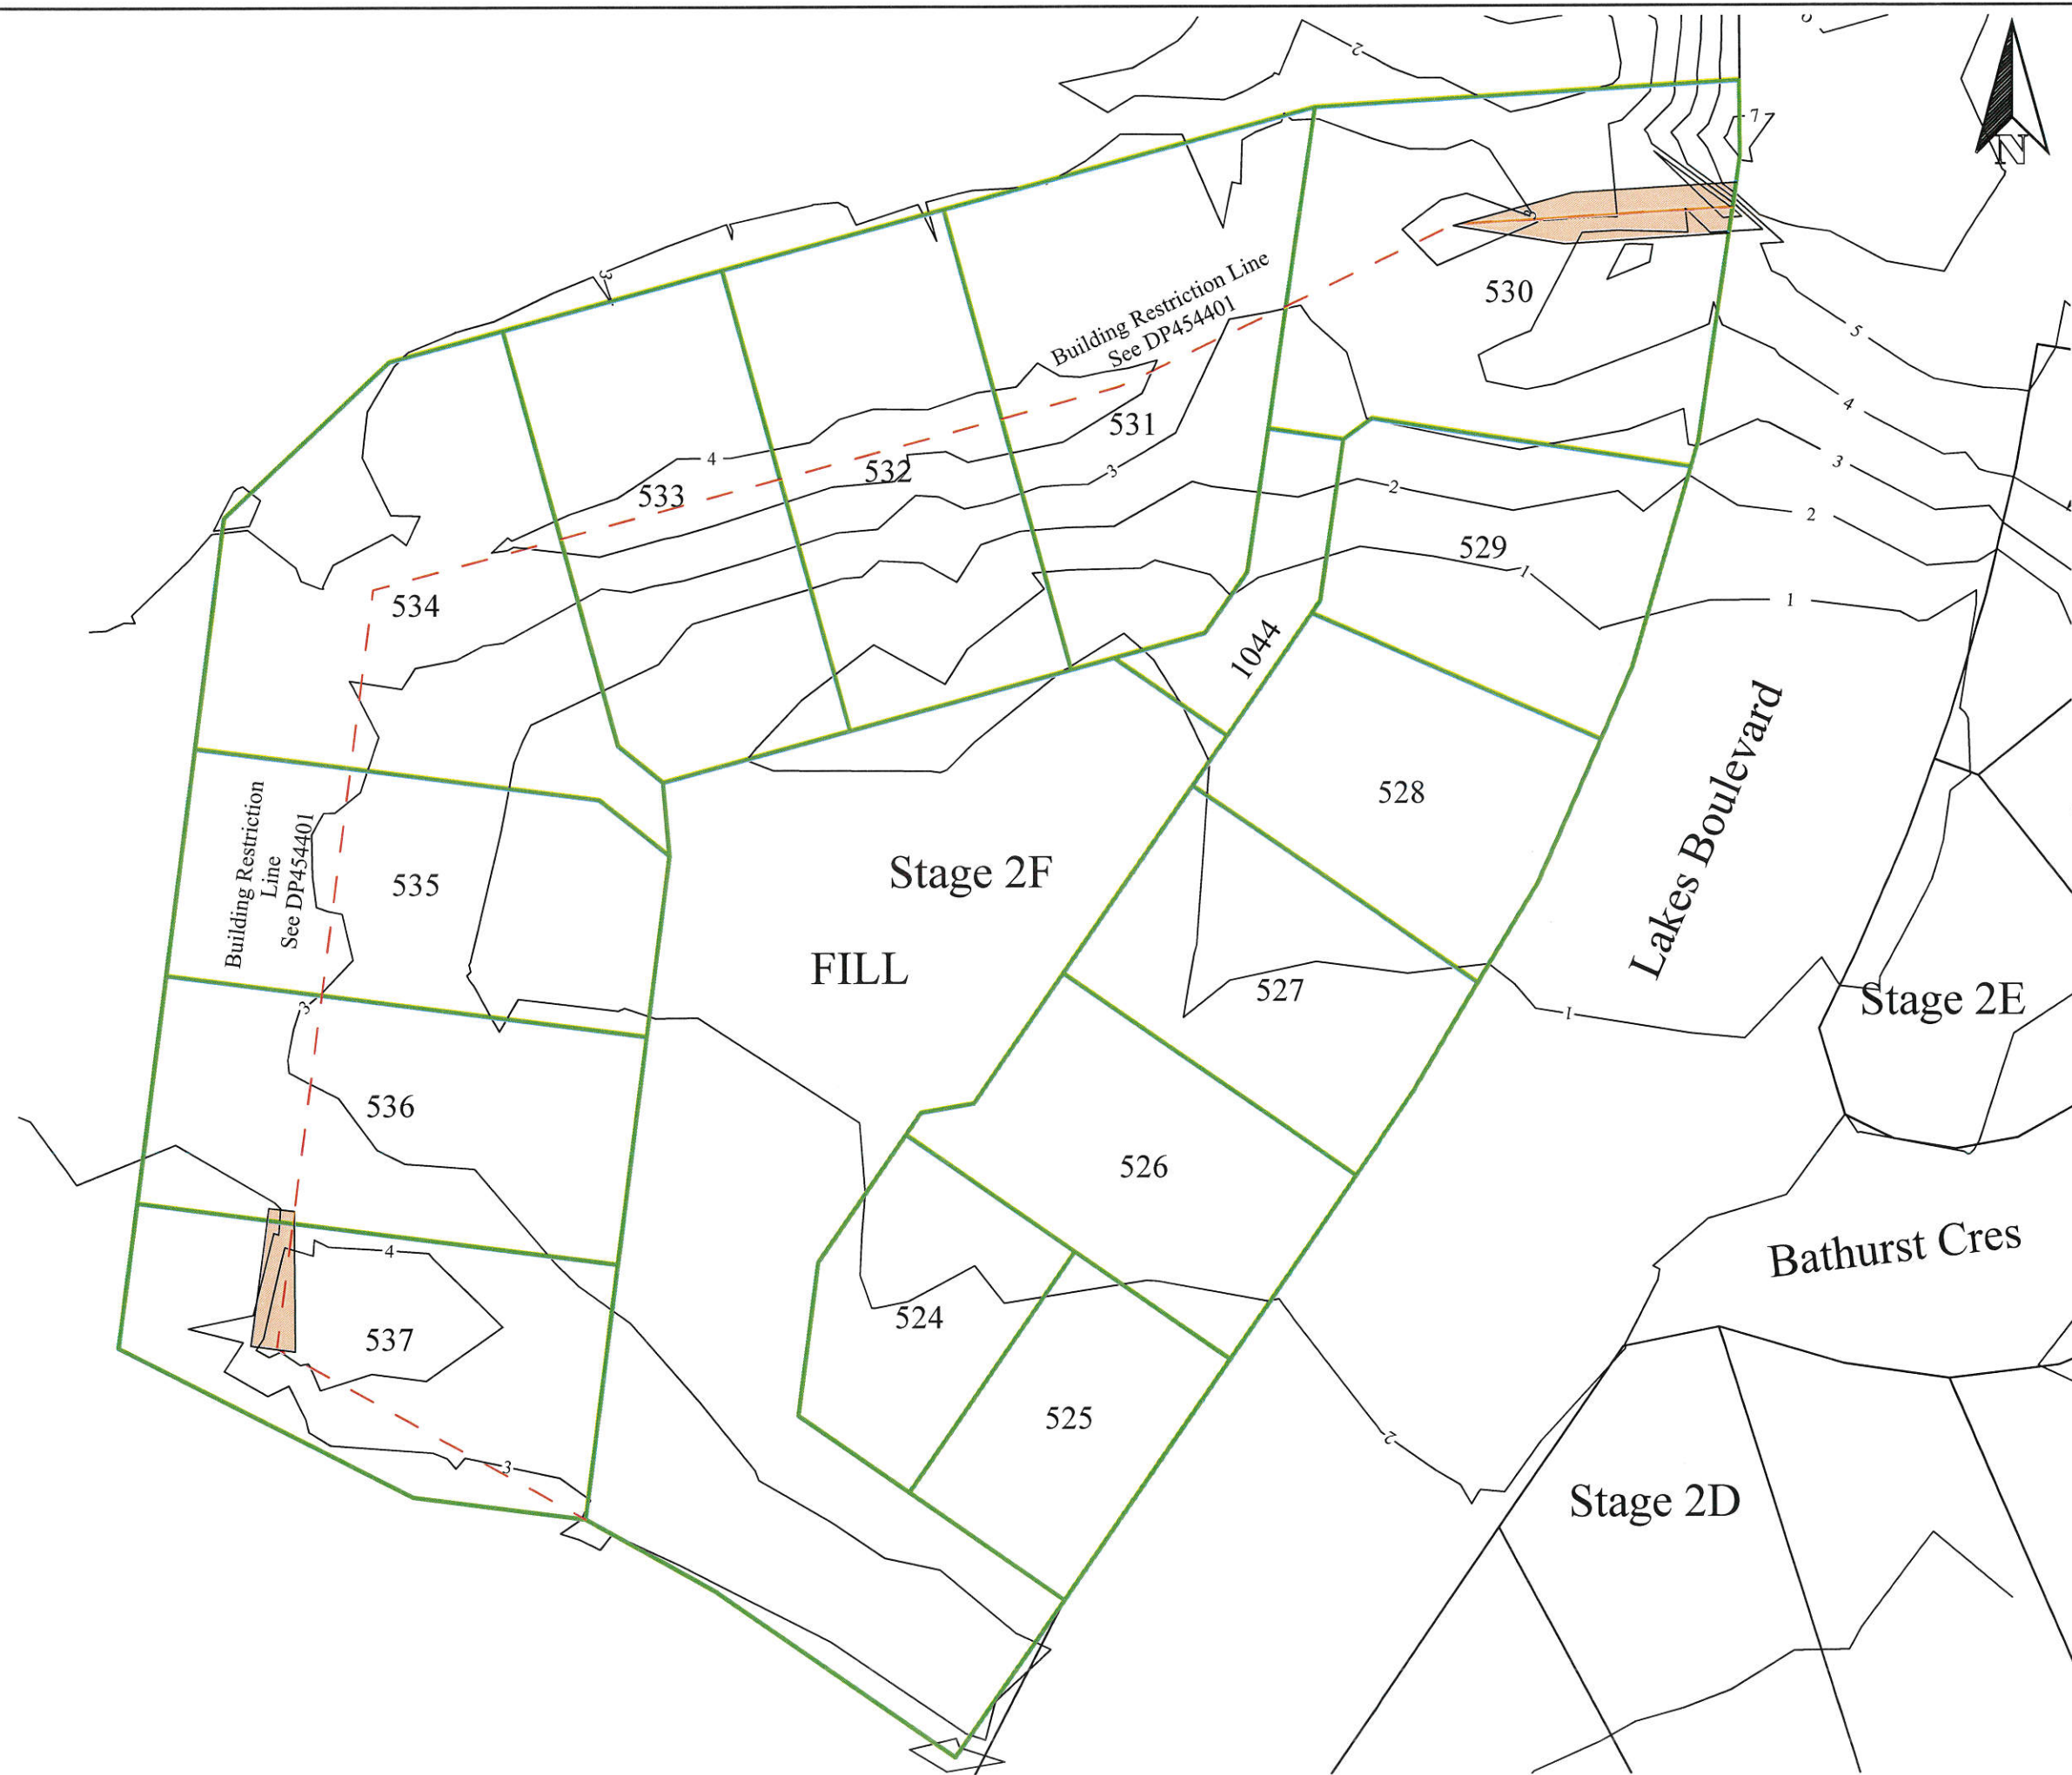
Earthworks Asbuilt
Depth of Cut / Fill

The earthworks undertaken in the Stage 2F area and as shown on 20180-AB8 comprised the removal of the surface peats and the replacement of the peat with filling obtained from borrow areas within The Lakes development. The areas where the peat was removed and replaced were governed by the capacity of the earthmoving machinery on the site and the cost effectiveness of removing the peat and undertaking its replacement.

The depths of cut and filling shown on 20180-AB8 were derived from surveyed contours of the finished surface taken on completion of the earthworks compared with topographical surveys undertaken by S&L Consultants Ltd prior to the subdivision construction and also surveys at the bases of excavations prior to the placement of the replacement filling.

Ground Improvement
Required on Lots 530
& 537

The extent of the structural filling shown on 18264-AB8 along the northern, southern and western margins of Stage 2F was determined by the practical limits to which the surface peat soils could be removed. The extent of the

Further investigations in 2012 found that on lots 530 and 537, the structural and non structural filling that is present on either side of the building restriction line at locations shown on 20180-AB8 revision 2 was not brought up to the finished ground surface in tandem. Some of the organic filling or topsoil beyond the building restriction line intrudes into the buildable areas by up to 2m and is up to 1.8m deep at the building restriction line on lot 530 and 1.0m deep on lot 537. In the future development of these lots the unsuitable filling is to be removed for a distance of 2m beyond the building restriction line and be replaced in accordance with NZS 4431 and be managed by a geotechnical consultant prequalified category 2 with the Tauranga City Council. The areas in which this work is to be undertaken on both lots are shown on 20180-AB8 revision 2.

The building restriction lines are indicated on 20180-AB8 and are shown on DP 454401.
