THE LAKES DEVELOPMENT VARIATION TO STAGE 2A PYES PA, TAURANGA

Geotechnical Assessment

Our ref: 18264
June 2007

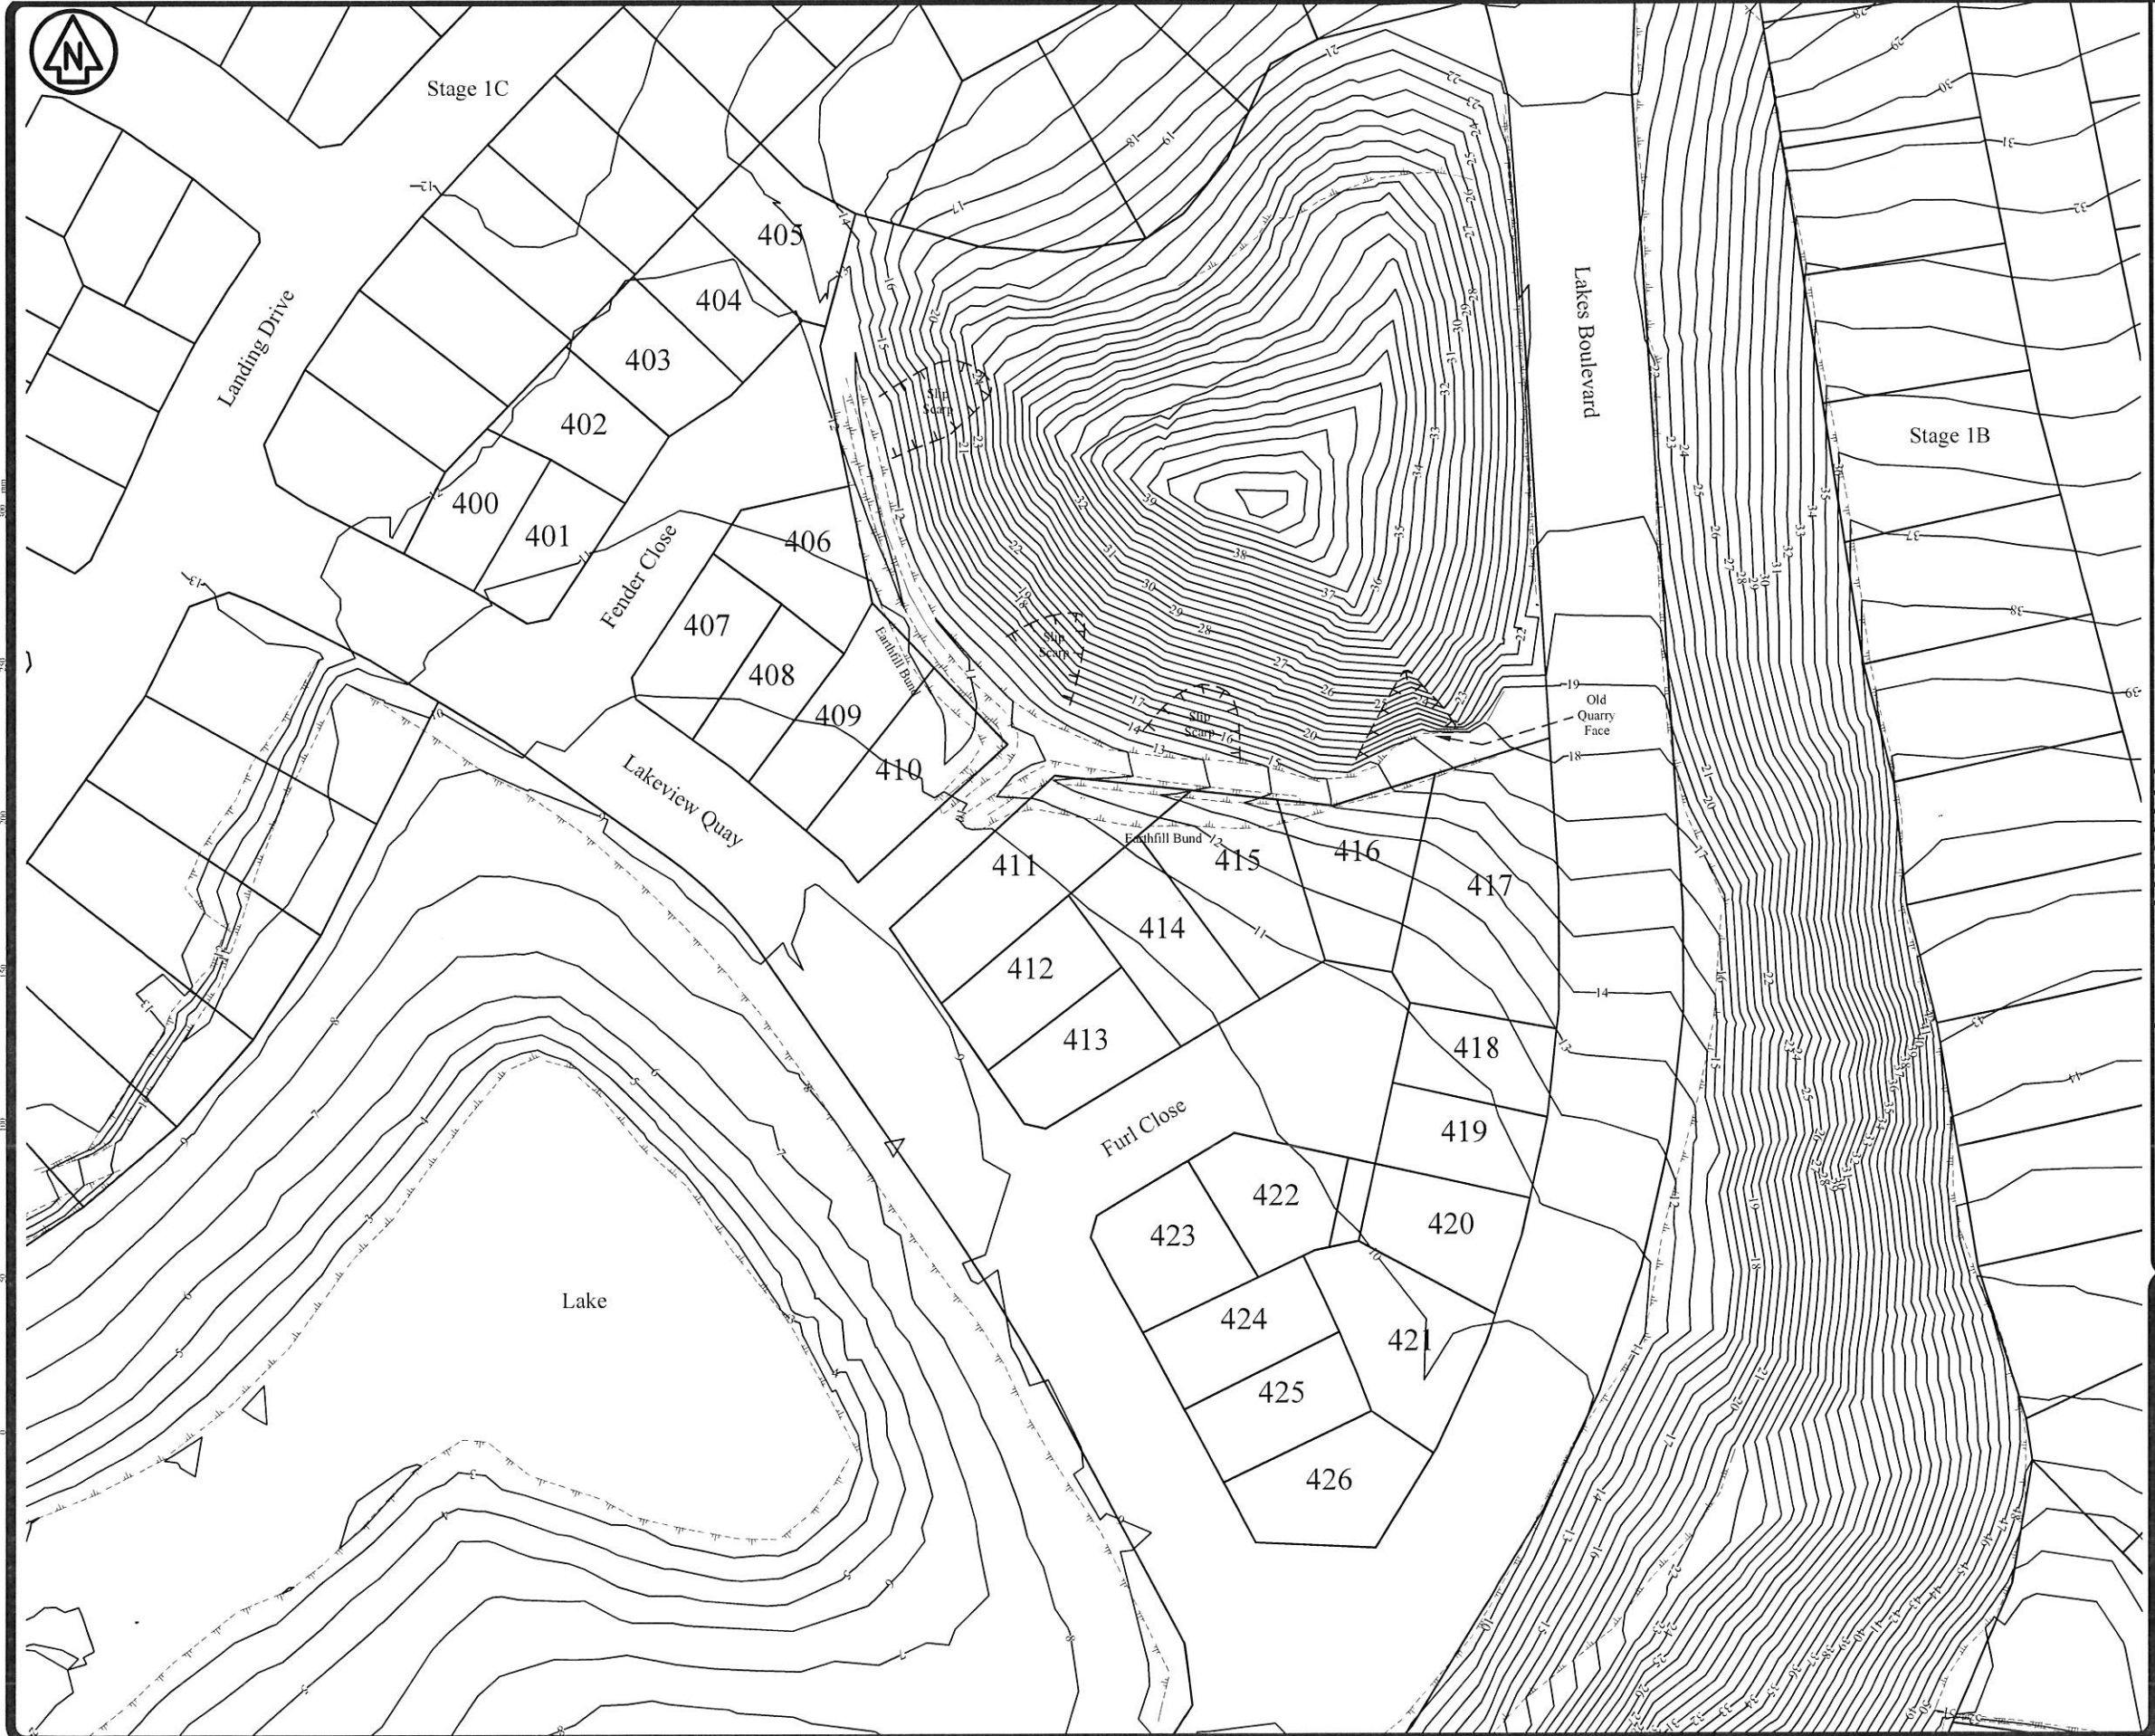
DRAWING No	
18264 - AB1

At the time of preparation of this report the earthworks within the Stage 2A area had been completed. Appended drawing AB1 shows the finished ground contours as the result of the completed earthworks. Drawing AB2 shows the depths of the filling that was placed, the locations of subsoil drains and the positions of compaction tests undertaken during the earthworks.

Earthworks Asbuilts

Final Contours

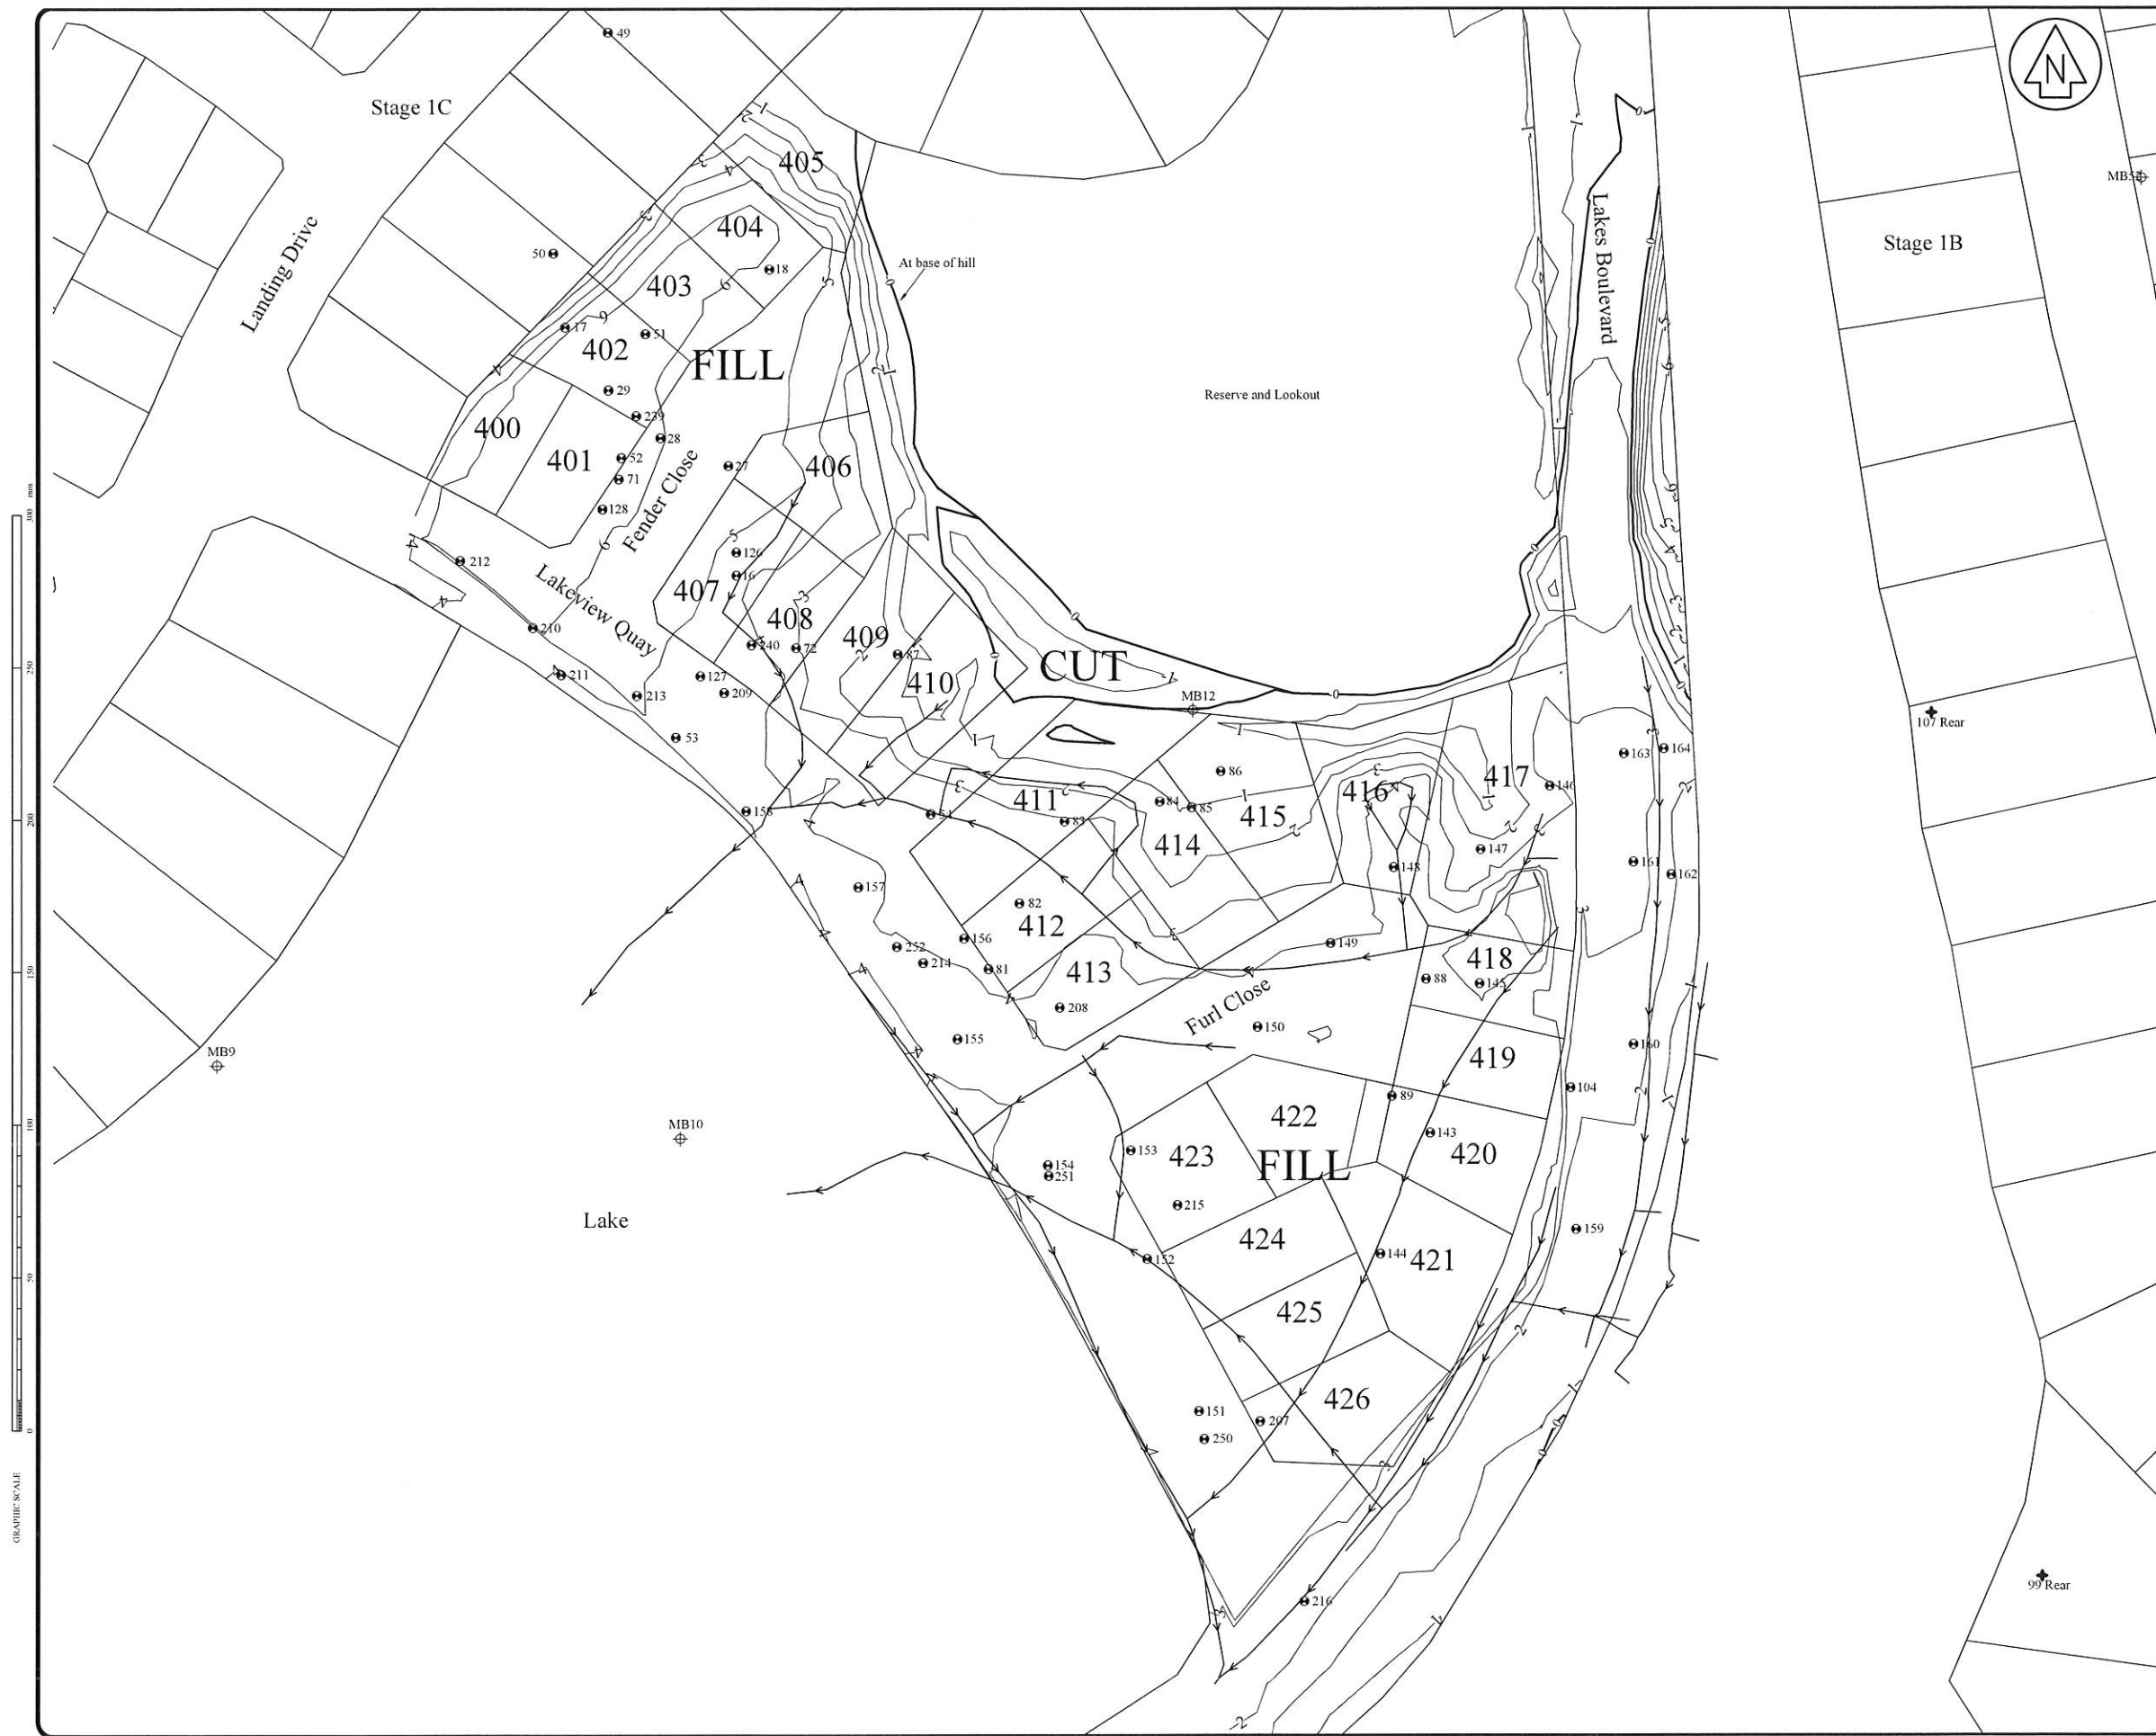
ORIGINAL SCALES	DATE
1:500 @ A1	06/07
DRAWING No	
18264 - AB2	
Revision	1 2

The earthworks undertaken in the Stage 2A area and as shown on 18264-AB2 comprised.

The depths of cut and filling shown on 18264-AB2 were derived from surveyed contours of the finished surface taken on completion of the earthworks compared with topographical surveys undertaken by S&L Consultants Ltd prior to the subdivision construction and also after the removal of the unsuitable surface soils and prior to the placement of the replacement filling.

63 compaction tests were undertaken within the areas of filling within the Stage 2A area at locations shown on 18264-AB2. The results of these tests are summarised in Appendix 3.

Supervised structural filling as shown on drawing 18264-AB2 was placed in accordance with the methods and standards quoted in NZS 4431 under the management of S & L Consultants Ltd. Compaction testing on site confirmed that a high and uniform degree of compaction has been achieved suitable for the support of buildings.

- Fill Compaction Test
- ◆ Post-subdivision construction borehole Stage 1B
- ⊕ Pre-subdivision Construction borehole
- Subsoil Drain
- 2- Depth of fill contour
- 2- Depth of cut contour

Depth of Cut/Fill

- (b) The earth fills shown on the attached Plan No. 18264-AB2 have been placed in accordance with the Code of Practice for Development of the Tauranga City Council.
